Site Visit Report

January 17, 2017

114 Merriam Road

Grafton Planning Board

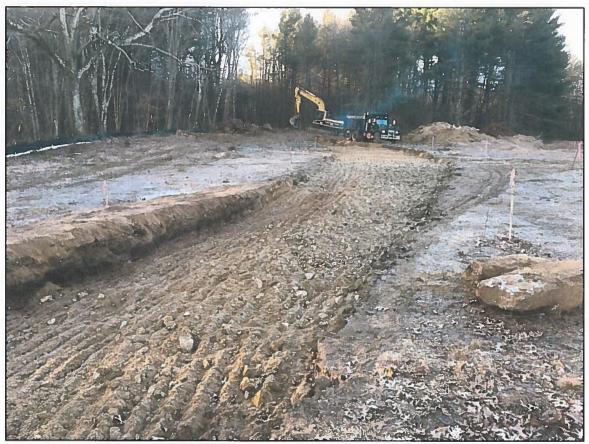
Topsoil and subsoil have been removed for approximately the first 300 feet of driveway (station 0+00 to 3+00). The excavation was 20 feet wide for an 18-foot paved roadway. It was informed by Mr. Orlando that 12" of gravel base material was to be installed and rolled on the prepared section of driveway today.

Photo 1: Excavation on roadway up to station 3+00.

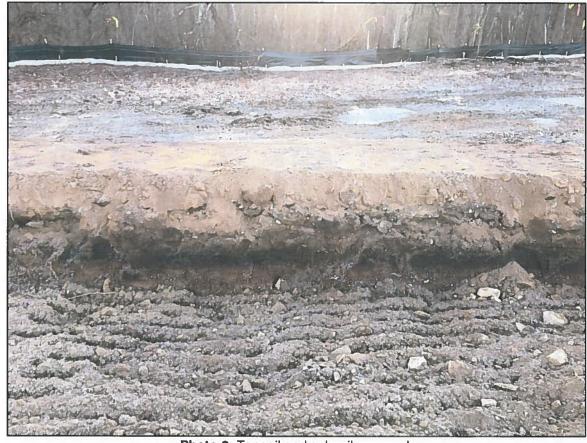
Photo 2: Topsoil and subsoil removed.
